Lookouts In The Southwestern Region

Cultural Resources Management Report No. 8

> USDA Forest Service Southwestern Region

September 1989

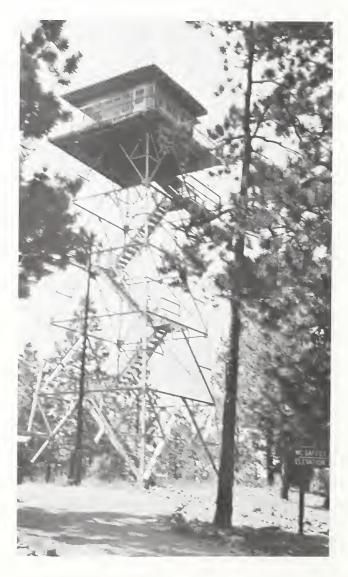
This lookout (Figure 116), located on the Mt. Taylor Ranger District, was erected in 1965. It is a USDA Forest Service Standard Plan CL-100 to CL-106 series type, with a 14 feet square steel

Figure 116. McGaffey lookout, Mt. Taylor Ranger District, Cibola National Forest.

cab resting on a steel tower 54 feet high. It replaced two earlier towers, a wooden tower built in the 1920s and an Aermotor MC-39 built in 1934. The McGaffey lookout, less than 50 years old, does not represent an exceptional type and is not recommended for National Registry eligibility.

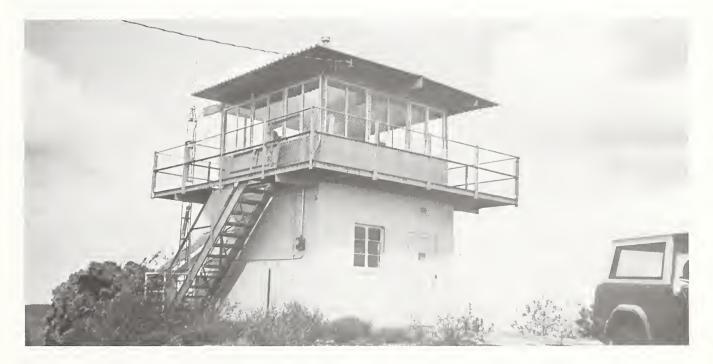
Constructed in 1965 on the Mount Taylor Ranger District, this lookout consists of a 14 feet square steel cab on a concrete blockhouse base 10 feet high. It is a USDA Forest Service Standard Plan CL-100 to CL-106 series type, also known as an R-6 flat (Figure 118). It replaced an earlier 7 feet by 7 feet wood cab on a 25 feet steel tower constructed in 1938. Since this lookout is less than 50 years old and represents an unexceptional type, it is not recommended for National Register eligibility.

Figure 118. Oso Ridge lookout, a 1958 version of the CL-100 series on Cibola National Forest.

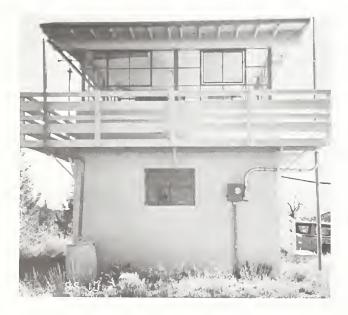
Davenport is located on the Magdalena Ranger District and was constructed in 1954 (Figure 120). This lookout consists of the standard CL-100 to CL-106 series configuration; a 14 feet square steel cab on a concrete blockhouse base 10 feet high. There are several private communications towers that intrude on this site. This lookout is less than 50 years old and does not represent an exceptional type. It is not recommended for National Registry eligibility.

Figure 120. Davenport lookout, Magdalena Ranger District, Cibola National Forest.

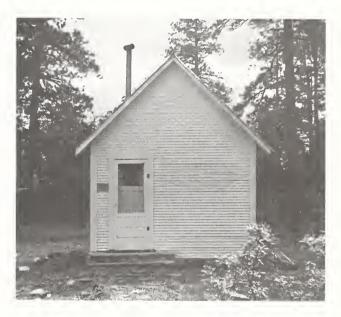
The Moqui cabin, constructed in 1932, sits on a rock masonry foundation. It is of wooden-frame construction with 2 by 8 joists, 1 by 4 decking, 2 by 4 wood rafters, 1 by 3 inch bevel siding and a corrugated steel roof. Comparisons of historic photographs indicate that the cabin has experienced only minor maintenance modification over the years. This cabin was built to provide living quarters for the fire guard who manned the early Aermotor tower at this site. The cabin has retained its original integrity of design and construction and is recommended for National Register eligibility.

Figure 123. Cabin at Moqui lookout, Coconino National Forest.

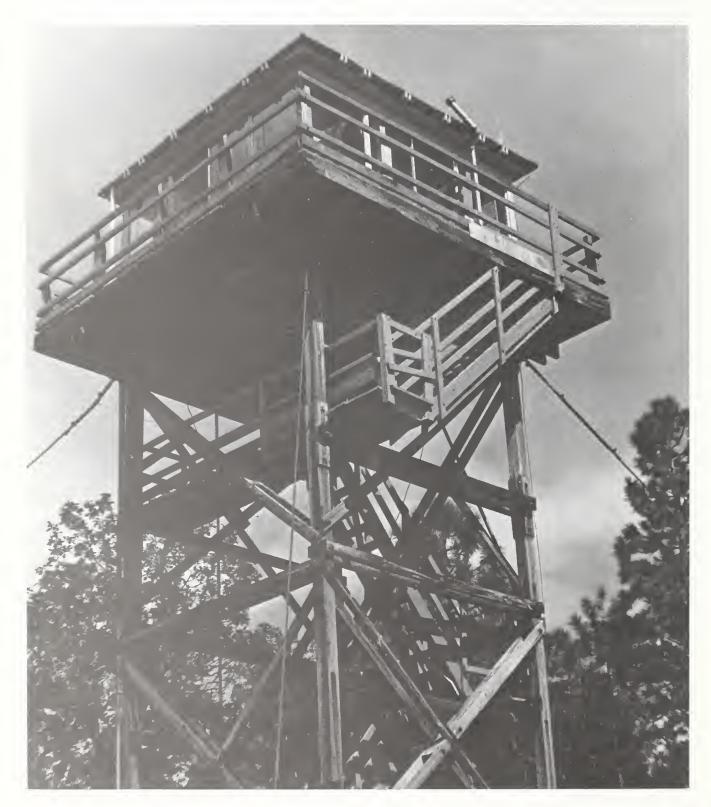
Located on the Flagstaff Ranger District, this USDA Forest Service CT-2 type Region 6 tower was constructed in 1943 (Figure 124). It is

"TECO-connected" (a trade name given to a metal coupling unit which allowed for the rapid and strong attachment of wooden structural units to other wooden units; designed and developed by the Timber Engineer Corporation of America). The L-4 lookout cab measures 14 feet square and sits on a 30 feet high, x-brace, wooden tower. It was probably constructed of wood due to a World War II steel shortage. The tower was fabricated by the Geeson Brothers Company.

Comparisons with historic photographs indicate window replacement. The CT-2 type lookout is represented by only two examples still extant in the Southwestern Region. Although there has been some loss of integrity due to window replacement, the lookout retains much of its integrity of design, construction, workmanship and materials and represents an exceptional type for the Southwestern Region. However, because it is less than 50 years old, it is not recommended for National Register eligibility.

Figure 124. East Pocket lookout, Coconino National Forest (CT-2 type).

in 1967 and the roof was given new shingles in 1983. This represents the best example of a surviving CT-2 type tower in the Southwestern Region. The only other CT-2 type is East Pocket Lookout (compare with Figure 124), also on the Coconino National Forest. Historic photographs indicate that Buck Mountain lookout has retained its integrity of original design, construction, workmanship, materials and location. The Lookout tower is 48 years old, but falls within the 1941 cutoff date for this historical period. It represents an exceptional type and is recommended as eligible for the National Register.

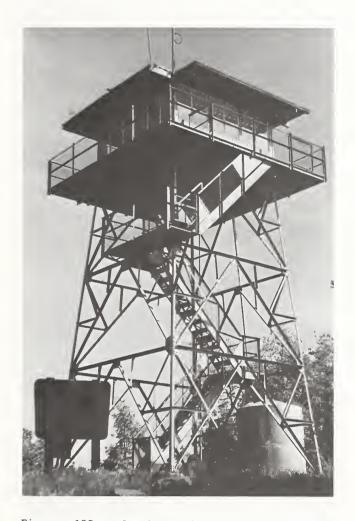
This lookout, located on the Beaver Creek Ranger District, was erected in 1961. It is 30 feet tall and represents a USDA Forest Service Standard Plan CL-100 to CL-106 series type, also known as an R-6 flat (Figure 125). The steel cab measures 14 feet square. The lookout was built by Martin Cline of Globe, Arizona. The steel utility building was also built in 1961. This lookout, less than 50 years old, does not represent an exceptional type and is not recommended for National Register eligibility.

Figure 125. Apache Maid lookout, Coconino National Forest (CL-100 series).

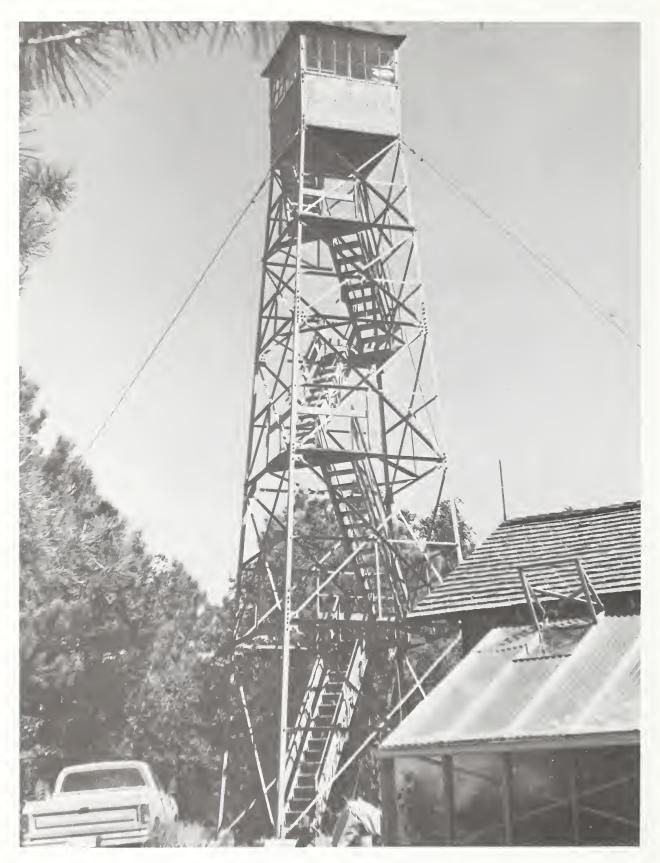
Located on the Flagstaff Ranger District, this 46 feet high tower with a steel cab 7 feet square was designed by the Pacific Coast Steel Company and erected by Charles Lochman and his CCC crew in 1936. This mountain had one of the two original lookout sites on the Coconino National Forest. From 1910 to 1921, fire guards climbed a lookout tree to detect fires. A wooden tower was built in 1922 and it was replaced by the present structure (Figures 126 and 127) in 1936.

There has been no major structural modification to this tower over the last 50 years. The lookout tower retains its original integrity of design, structure, location, workmanship and materials; represents an exceptional type; and is over 50 years of age. It is recommended for National Register eligibility.

Figure 126. Woody Mountain lookout (designed by Pacific Coast Steel) on Coconino National Forest.

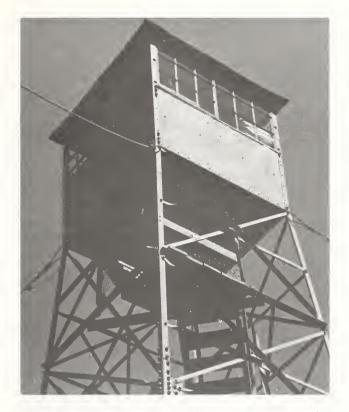
Figure 127. Woody Mountain lookout, Coconino National Forest (showing details of the cab).

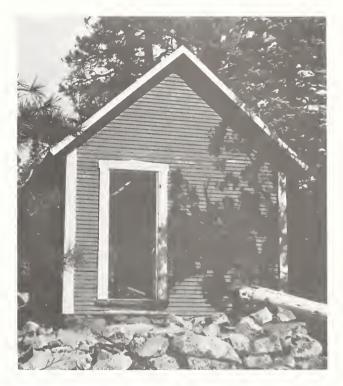
This lookout is located on the Mormon Lake Ranger District and was erected in 1927. The steel tower is 50 feet high and has a steel cab 7 feet square. It is an Aermotor LX-24 type which replaced a 1915 wooden tower. The associated wood frame cabin was built in 1928 (Figures 128 and 129).

The interior of the cabin was constructed using 2 by 4 inch studs, while the siding is shiplap pine. Study of historic photographs indicates that modification of the original windows in the tower has occurred; the cabin has experienced no major modifications. The cabin is a standard plan similar to the cabin at the East Pocket lookout. The lookout tower has lost its original integrity of design, construction, workmanship and materials due to the window replacement. The lookout tower is not recommended for National Register eligibility. The lookout cabin has retained these integrity factors and is recommended for National Register eligibility.

Figure 129. Mormon Lake lookout cabin, Coconino National Forest.

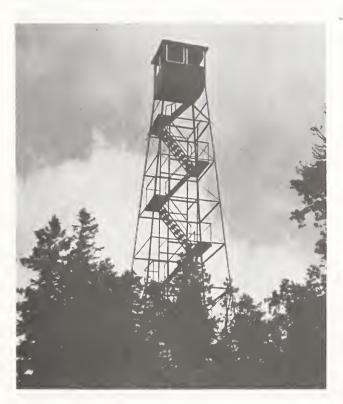
Figure 128. Mormon Lake lookout, an Aermotor LX-24, on the Coconino National Forest.

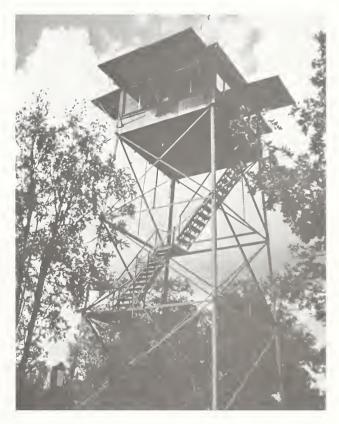
Located on the Long Valley Ranger District, this 30 feet high Aermotor MC-24 Tower has a steel cab

Figure 130. Baker Butte lookout, a 30 feet tall Aermotor MC-24, on Coconino National Forest.

12 feet square. It was erected in 1937 by a CCC crew. This tower replaced an early wooden tower built in 1922. The wooden frame cabin was built in 1930. One room was added in 1946. Both the lookout tower and cabin (Figures 130 - 131) have experienced extensive modifications and have lost their original integrity of design, construction, workmanship and materials. They are not recommended for National Register eligibility.

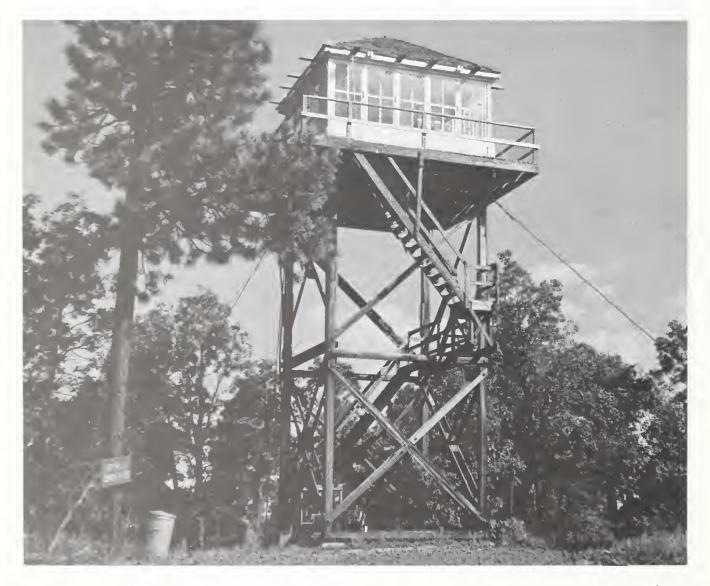
Located on the Long Valley Ranger District, this CT-2 wooden, x-brace, tower is 30 feet high and has a 14 feet by 14 feet L-4 wooden cab on top (Figure 132). It was built in 1939, probably by a CCC crew. The steps were slightly altered in 1953. The timbers were treated for preservation

Figure 132. Buck Mountain lookout, one of only two examples of the CT-2 type, both on the Coconino.

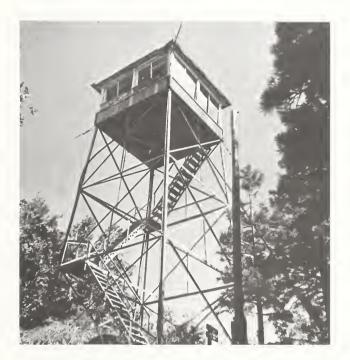
This Aermotor MC-24 tower (Figure 133) stands 48 feet high and has a cab 12 feet square. It was built by a CCC crew in 1936. It is located on the Long Valley Ranger District. This lookout tower replaced a wooden tower built in the early 1920s. The windows have been replaced and the tower has lost its integrity of design, construction, materials and workmanship. It is not recommended for National Register eligibility.

Figure 133. Hutch Mountain lookout, a 48 feet tall Aermotor MC-24 built in 1936.

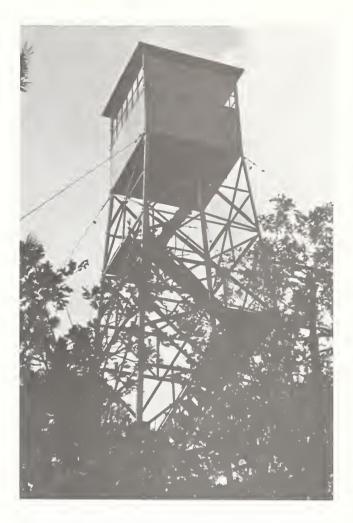
This 45 feet 9 inch high steel tower with a 7 ft by 7 ft steel cab is located on the Mormon Lake Ranger District and was built in 1933. It

Figure 134. Lee Butte lookout, an International Derrick type built in 1933 on the Coconino.

represents the only example of an International Derrick and Equipment Company steel tower in the Southwestern Region (Figures 134 and 135). The accompanying wood-frame cabin was also built in 1933. Historical photographs indicate that no major modifications have occurred to either the lookout tower or the cab. Both the tower and cabin are more than 50 years old and retain integrity of original design, construction, location, materials and workmanship and both are recommended for National Register eligibility.

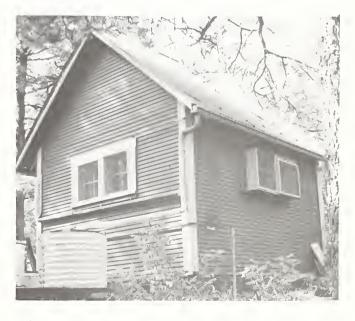
Figure 135. Lee Butte lookout's cabin, viewed to the Southwest, on Mormon Lake Ranger District.

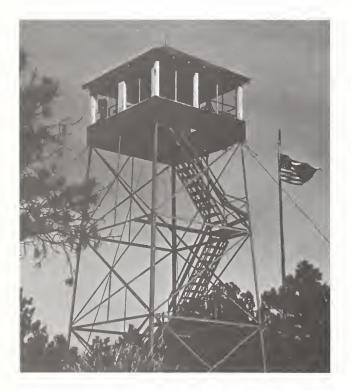
This Aermotor MC-24 steel tower is 30 feet high and has a steel cab 12 feet square (Figure 136). It is located on the Flagstaff Ranger District and was erected in 1937 by Vince Purtle and his CCC crew. The cabin was constructed in 1984 replacing an earlier 1943 cabin. Extensive modifications have been made to the windows and the tower has lost its integrity of original design and construction and is not recommended for National Register eligibility.

Figure 136. Turkey Butte lookout, an Aermotor MC-24 erected by the CCC in 1937.

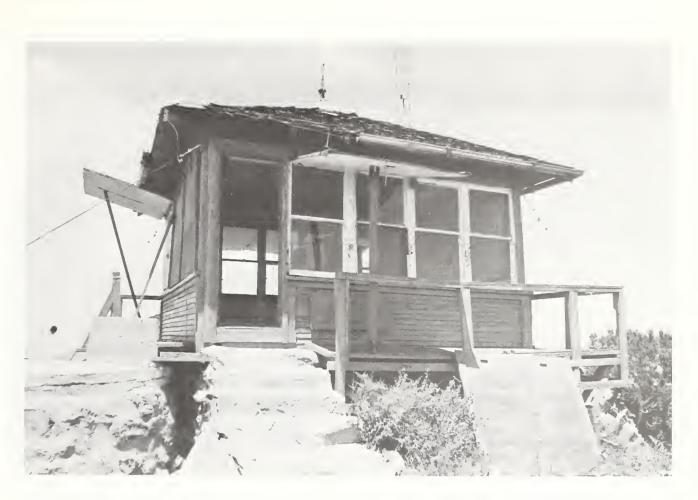
This lookout house is located on the Nogales Ranger District and was erected in 1930 or 1933 by the Forest Service. The lookout is no longer being used as a fire detection facility but is now a rest area for hikers; it is accessible by trail only. This lookout is an L-4 type wooden house with dimensions of 14 feet by 14 feet (Figure 137). Historic photographs indicate that there has been minimal modification since 1933. The associated outhouse and stone cistern were also built in 1933 and exhibit no apparent modification. This lookout house, as well as the cistern and outhouse, have retained their integrity of original design, construction,

Figure 137. Atascosa lookout, an L-4 house, was built circa 1933. Note the cistern at the left. This site is no longer in use as a lookout for the Coronado National Forest

workmanship, materials, setting, location and association and are recommended for National. Register eligibility.

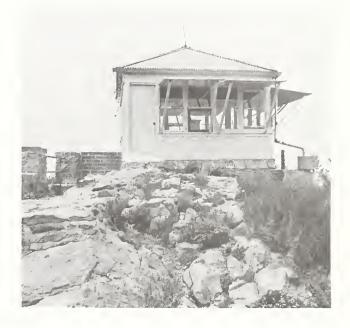
Barfoot lookout is located on the Douglas Ranger District and was built in 1935, possibly by a CCC crew. The lookout house is an L-4 type wooden house measuring 14 feet square. This complex also includes a wooden frame shed, outhouse, concrete cistern and an attractive, rustic style native stone retaining wall (Figures 138 - 141). The lookout complex represents one of the best examples of its type in the Southwestern Region.

Study of historic photographs indicates no major modifications have occurred to any of the structures at this complex. The lookout house and other structures have all retained their integrity of original design, construction, workmanship, materials, setting, location and association and the entire complex at Barfoot is recommended for National Register eligibility.

Figure 138. Barfoot lookout, an L-4 house type, on the Coronado National Forest.

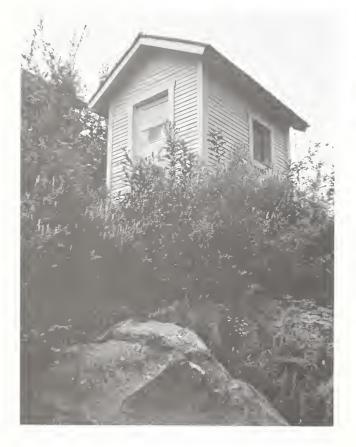
Figure 140. Storage shed at Barfoot lookout on the Coronado National Forest.

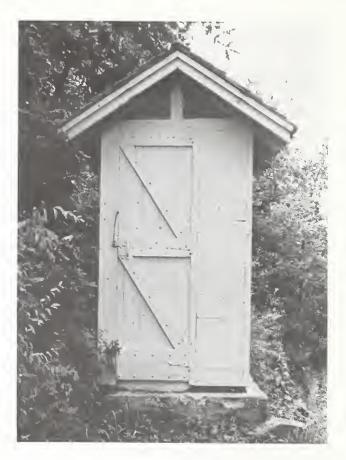
Figure 141. Barfoot lookout's privy.

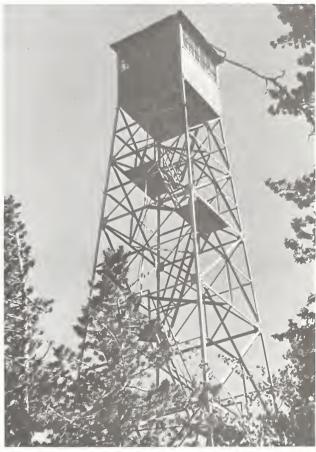
Aermotor MC-40 steel tower is approximately 45 feet high. It has a steel cab 7 feet square (Figures 144 and 145). It was erected in 1933, possibly by a CCC crew. The original living quarters cabin was removed in 1968 and replaced Historic photographs by a modern structure. indicate that no major structural changes have occurred to the lookout tower since it was erected. This lookout is over 50 years old, retains its integrity or original design, construction, workmanship, materials, setting, location and association and is recommended for National Register eligibility.

Figure 144. Webb Peak lookout, an Aermotor MC-40, on the Coronado National Forest.

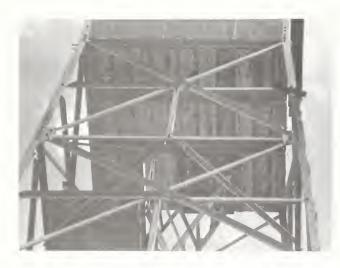
Figure 145. Details of bracing on the Coronado's Webb Peak lookout tower.

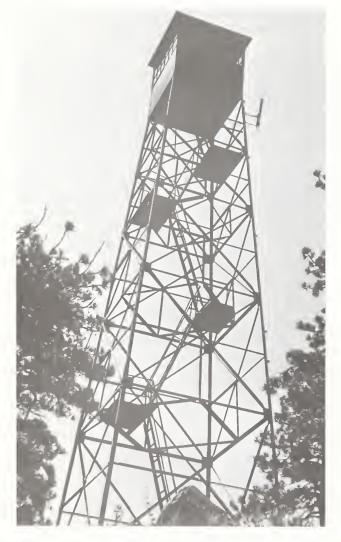
Figure 146. West Peak lookout, another Aermotor MC-40, Coronado National Forest.

Located on the Safford Ranger District, this 45 feet high Aermotor MC-40 steel lookout tower has a steel cab 7 feet square (Figures 146 - 148). It was erected in 1933 by a CCC crew. The original log cabin associated with this lookout was removed in 1959. Study of historic photographs reveals that no major structural changes have occurred to the tower. This lookout is over 50 years of age, retains its integrity of original design, construction, workmanship, materials, setting, location and association and is recommended for National Register eligibility.

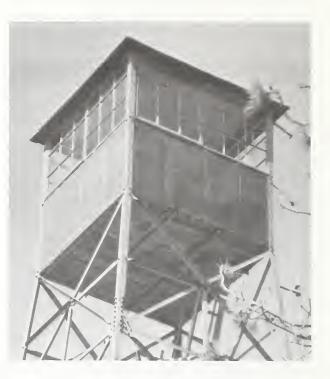
Figure 147. The cab on the Coronado's West Peak lookout (Aermotor MC-40).

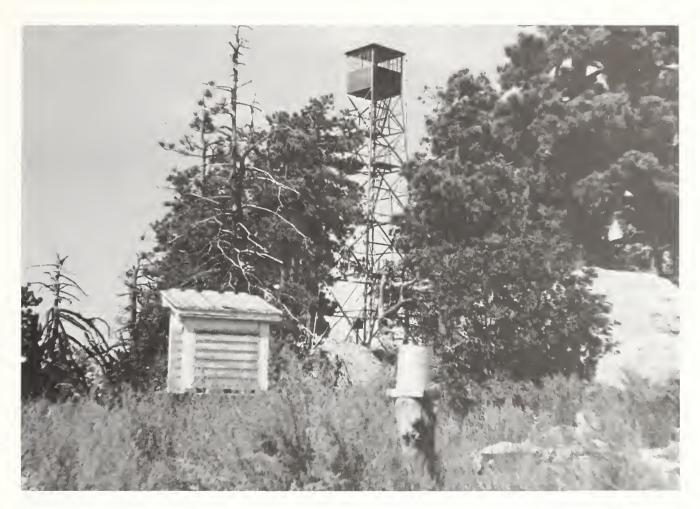
Figure 148. A rain gauge and weather station at West Peak lookout, Coronado National Forest.

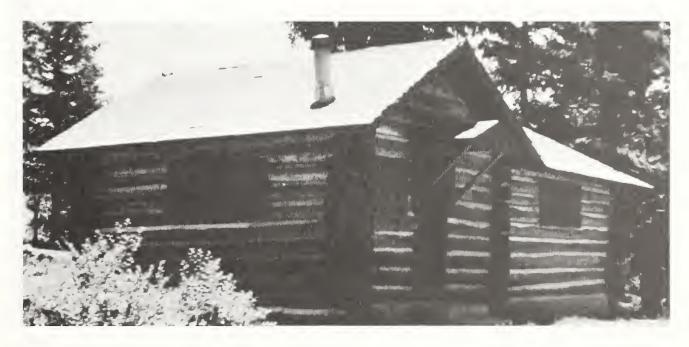
Figure 149. Heliograph lookout's cabin was built in the rustic style in 1933.

design, construction, workmanship, materials, setting, location and association. All of the Heliograph structures (Figures 149 - 152) are over 50 years old and the entire complex is recommended for National Register eligibility.

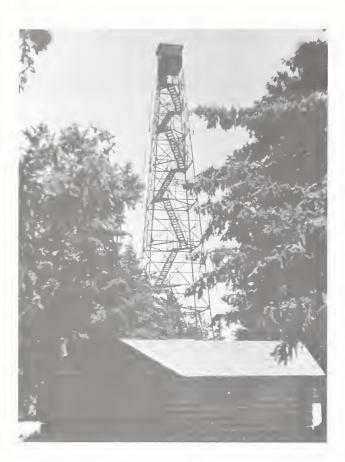
Figure 150. Heliograph lookout (Aermotor MC-40) and cabin, Coronado National Forest.

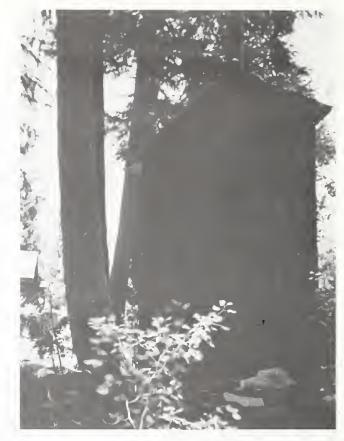
Figure 151. Heliograph lookout's privy, Coronado National Forest.

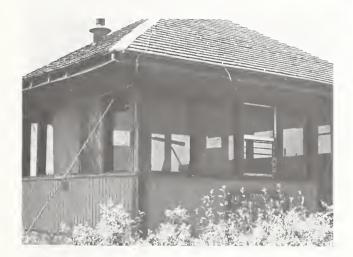
Located on the Patagonia Ranger District, this lookout (Figure 153) was erected in 1926. The wooden frame lookout house is an L-4 type and measures 14 feet square. Although no historic photographs were located for this lookout, it appears that major structural modifications have occurred, including changes to the roof, windows and sidings. The lookout house does not retain its integrity of original design, construction, workmanship and materials and is not recommended for National Register status.

Figure 153. Miller Peak lookout, an L-4 house built in 1926 for the Coronado National Forest.

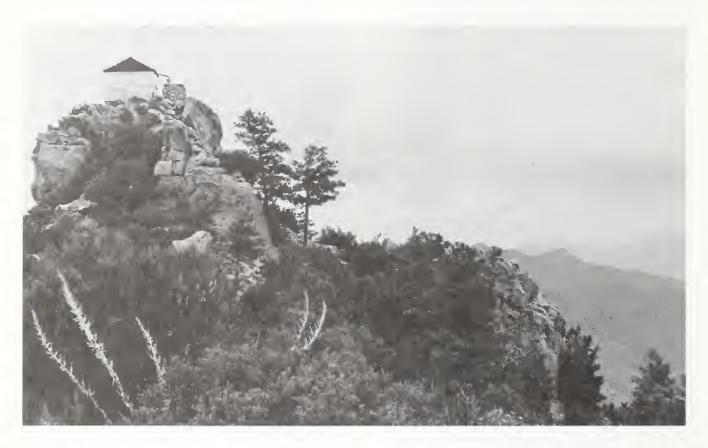
This lookout house, an L-4 type located on the Douglas Ranger District, was erected in 1938, perhaps by a CCC crew. It is situated on top of a rocky knob (Figure 156). This wood frame construction measures 14 feet square. There are several associated buildings (Figures 157 and 158) including an outhouse and storage shed, both are wood frame construction with tongue and groove exterior. There also is a water cistern (Figure 159) with a catchment drain extending from the roof of the lookout house.

This lookout complex has suffered no modern intrusion and has retained remarkable integrity

Figure 156. Silver Peak lookout, an L-4 house, built in 1938 on the Coronado National Forest.

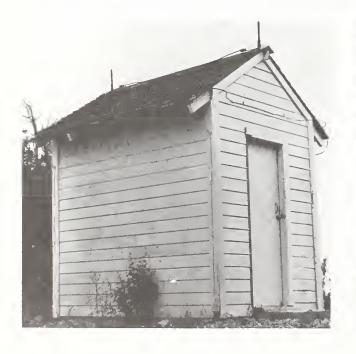
Figure 157. Silver Peak lookout privy, Coronado National Forest

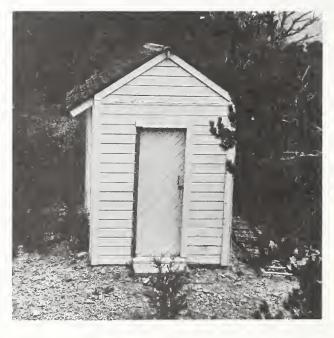
Figure 158. Silver Peak lookout storage shed, Coronado National Forest

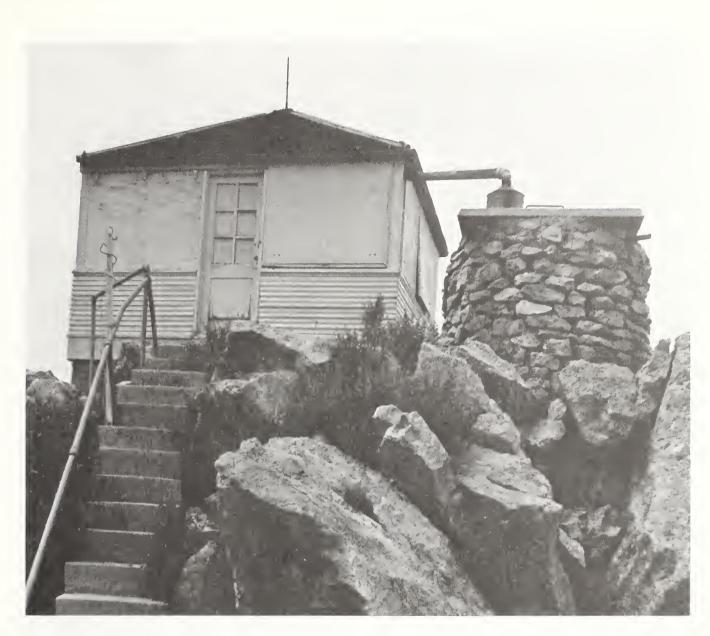
Figure 159. Silver Peak lookout and its cistern, Douglas Ranger District, Coronado National Forest.

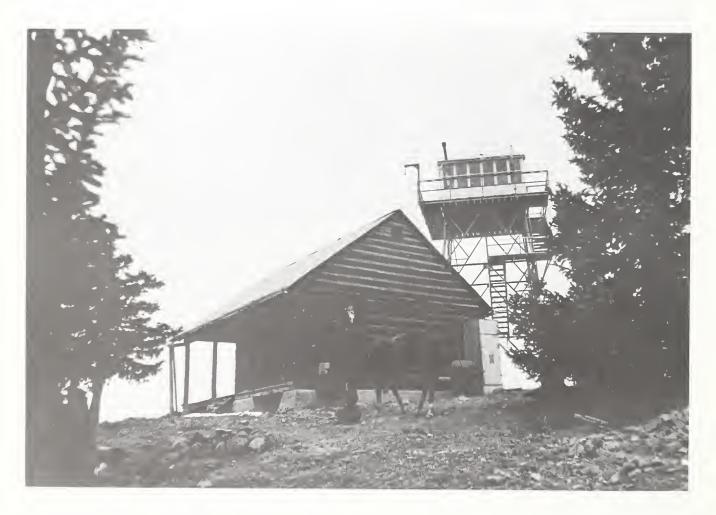
Located on the Wilderness Ranger District, this 30 feet high Aermotor MI-25 steel tower has a wooden cab 14 feet square. The lookout was built in 1948 on a location which has been utilized for fire detection since at least 1913 when fires were located with a protractor on top of a stump. A wooden tower was built in 1917 and the top of the platform was enclosed in 1921. The wooden tower was then replaced by the present steel tower. Adjacent to the lookout tower is a log cabin built in 1923 (Figures 161 and 162).

Study of historic photographs indicates that no major structural changes have occurred to either building. The tower represents a rare and exceptional type of Aermotor tower. Only two MI-25 type towers have survived in the Southwestern Region; the other being on the Lincoln National Forest. However, the tower is less than 50 years old and does not fall within the 1941 cut off date, so it is not recommended for National Register eligibility. The cabin retains excellent integrity of original design, construction, workmanship, materials and setting and it is recommended for National Register eligibility.

Figure 161. Mogollon Baldy lookout tower, an Aermotor MI-25, and cabin (built in 1923) on the Gila.

This lookout, a 30 feet high steel tower with a wooden cab 14 feet square, is an Aermotor MI-25 type. It was erected in 1940 on the Smokey Bear Ranger District. The Aermotor MI-25 type is an unusual and rare type of lookout in the Southwestern Region (Figure 210). Only one other MI-25 is known, that being located on the Gila National Forest [See Figures 161 and 162].

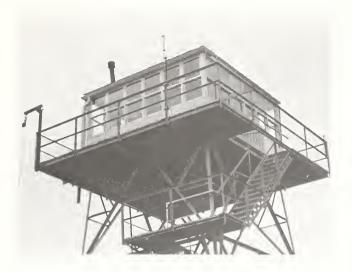
Figure 162. The cab of Mogollon Baldy lookout, an Aermotor MI-25, on the Gila National Forest.

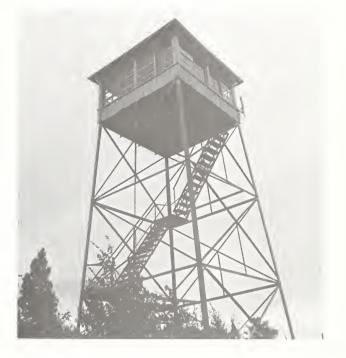
Located on the Quemado Ranger District, this lookout tower was erected in 1934. It is an Aermotor MC-24. There is a 14 feet square steel cab on a steel tower 30 feet high. The wooden frame cabin was erected in 1934. The lookout tower and cabin (Figures 164 - 166) show few modifications over time and appear to retain much of the integrity of the original design, construction, workmanship, materials, setting, location and association. The tower and cabin are over 50 years old and are recommended for National Register eligibility. This tower was previously recommended for eligibility by the New Mexico State Historic Preservation Office.

Figure 164. Mangas Mountain lookout, an Aermotor MC-24 type, on the Gila National Forest.

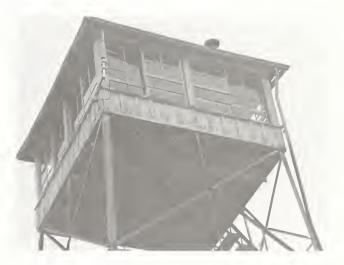
Figure 165. The cab of Mangas Mountain lookout (Aermotor MC-24), Gila National Forest.

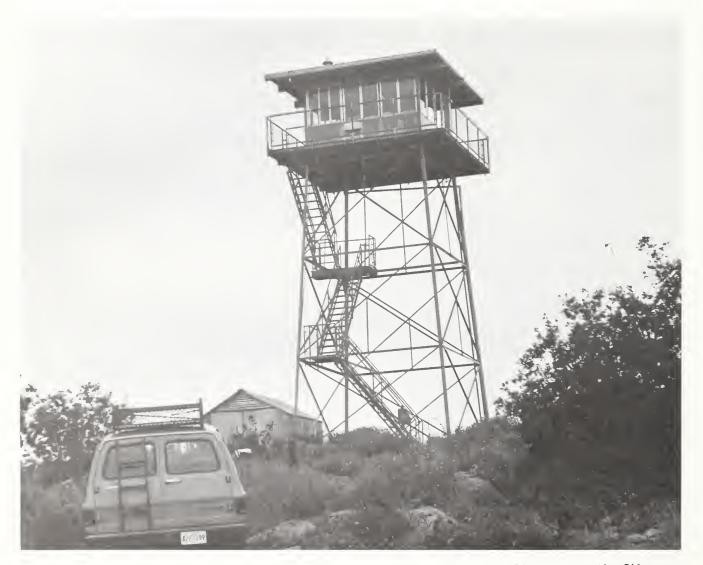
Figure 167. Saddle Mountain lookout, a CL-100 series cab on a Aermotor MC-24 tower, on the Gila.

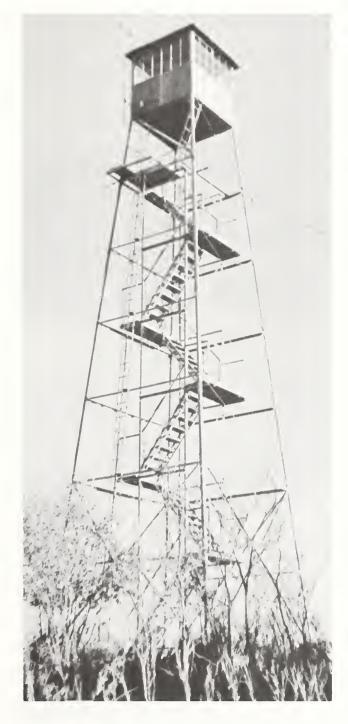
This lookout is located on the Luna Ranger District and was erected in 1933 (Figure 167). The original lookout was an Aermotor MC-24 type, but the cab was replaced in 1966 by a USDA Forest Service Standard Plan CL-100 to CL-106, 14 feet square steel cab. All of the other outbuildings are of recent construction. This tower has been extensively modified and has lost its integrity of original design and construction. It is not recommended for National Register eligibility.

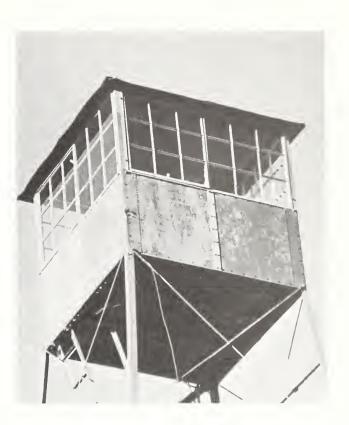
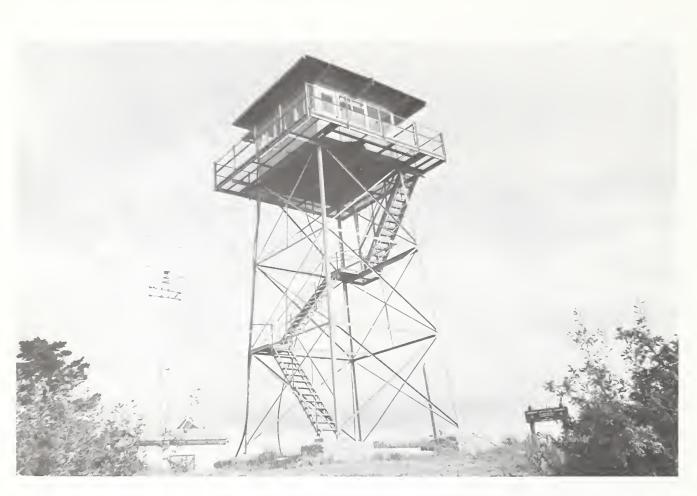
Located on the Mimbres Ranger District, Reeds Peak has a 48 feet high Aermotor LX-24 steel tower (Figures 168 and 169). The steel cab is 7

feet square and was erected in 1929. New stairs were added in 1965, but the original ladder is still in place. The original cabin was replaced in 1959. This lookout retains its integrity of original design, construction, workmanship, materials, setting, location and association and is over 50 years old. It is recommended for National Register eligibility.

Figure 168. Reeds Peak lookout, an Aermotor LX-24, Gila National Forest.

Figure 169. Reeds Peak lookout cab, Mimbres Ranger District.

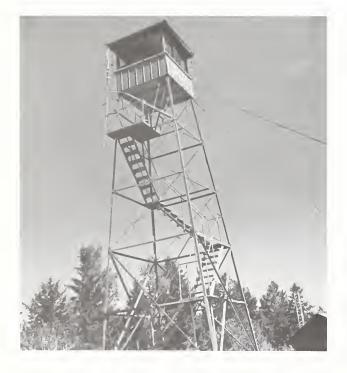
Located on the Black Range Ranger District, this 30 feet high MC-24 Aermotor steel tower was erected in 1933. The original 12 feet square wooden cab was replaced by a CL-100 series 14 feet square cab in 1965 (Figure 170). The outbuildings are all of recent construction. The lookout tower has been extensively modified with new windows and siding. It has lost its integrity of original design, construction, workmanship and materials and is not recommended for National Register eligibility.

Figure 170. The Lookout Mountain site with its CL-100 series lookout, Gila National Forest.

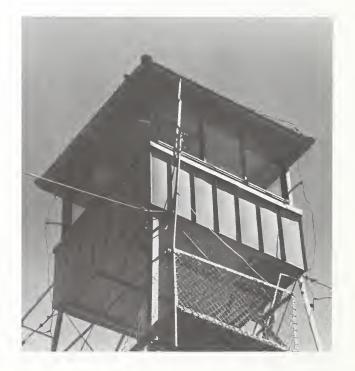
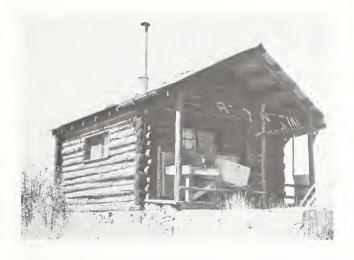
The Bearwallow lookout was erected in 1923 on the Glenwood Ranger District. This lookout is an Aermotor LX-24, 35 feet high with a wooden cab 7 feet square. The lookout tower has been extensively remodeled. The original windows were completely replaced, new stairs installed and the roof and exterior walls covered with steel in 1984 (Figures 171 and 172).

Figure 171. Bearwallow lookout site with another Aermotor LX-24, Gila National Forest.

Figure 172. Bearwallow lookout's cab, Glenwood Ranger District, Gila National Forest.

(Figure 174) and the privy were erected in 1940. The two log cabins show few changes since their construction. Both log cabins have retained their integrity of original design and both are recommended for National Register eligibility. The lookout tower is not, as it has been so extensively remodeled that it has lost its integrity of design, workmanship and materials.

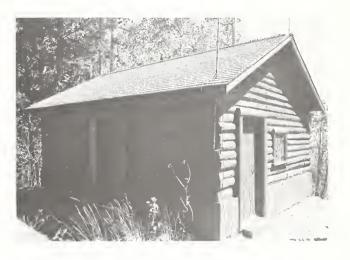
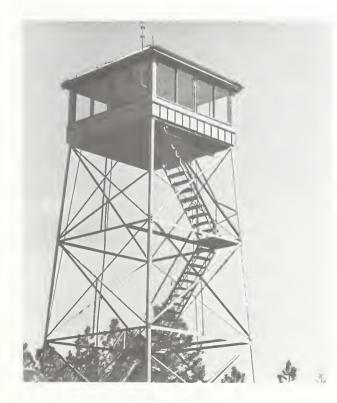
The upper log cabin (Figure 173) was built in 1923 and the lower cabin, formerly a barn,

Figure 173. Log cabin at Bearwallow lookout cabin, Gila National Forest.

Figure 174. Bearwallow lookout cabin, Gila National Forest.

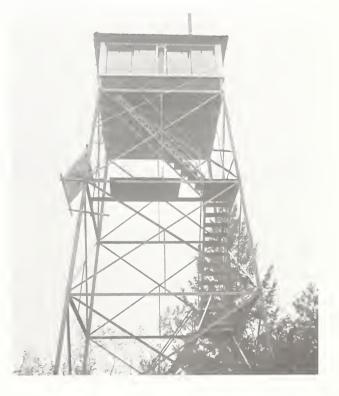
Located on the Reserve Ranger District, this Aermotor MC-24, steel tower 30 feet high with a 12 feet square wood cab was erected in 1934. The lookout was extensively remodeled in 1984, with new windows, new steel siding and a new roof (Figure 175). The lookout has lost its integrity of original design, construction, materials and workmanship and is not recommended for National Register eligibility.

Figure 175. Negrito Mountain lookout.

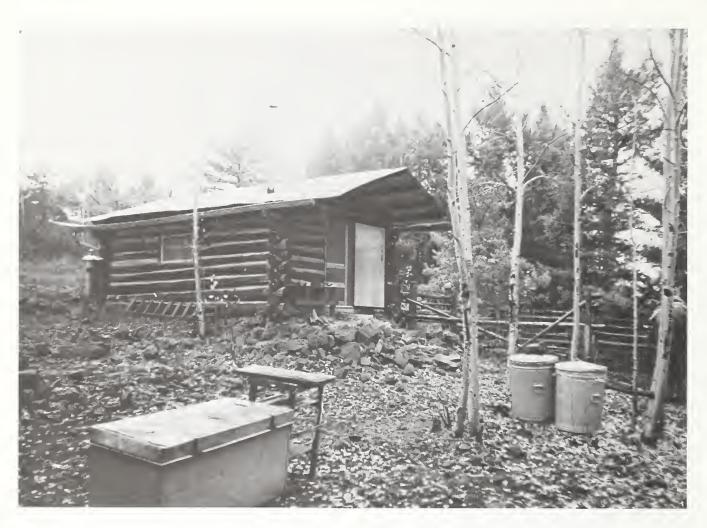
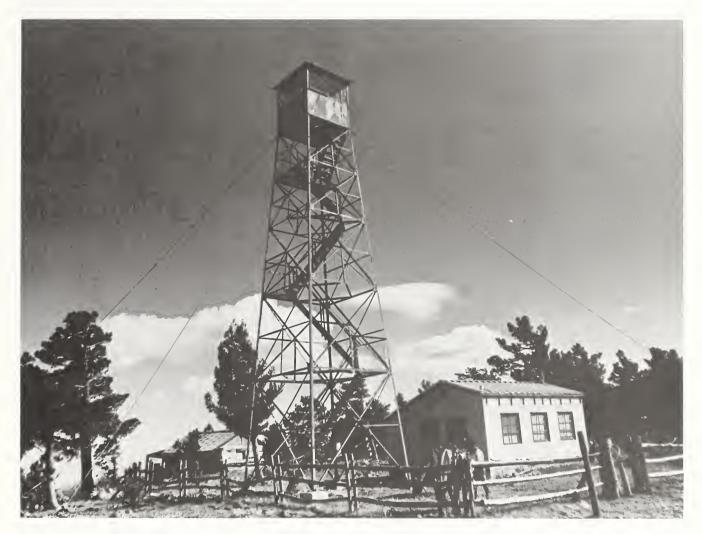
Figure 176. Black Mountain lookout.

Figure 177. The Black Mountain lookout cabin was built in 1925 on the Gila National Forest.

This lookout was constructed in 1934 and is located on the Black Range Ranger District (Figures 176 and 177). The 30 feet high Aermotor MC-24 with a wooden cab 12 feet square was remodeled in 1978. All of the original windows were replaced at that time. This lookout replaced an earlier wooden tower built in the 1920s. The present cabin was built in 1925 and is little changed. The lookout tower has not retained its integrity of original design and construction and is not recommended for National Register eligibility. However, the log cabin is over 50 years of age, has retained its integrity of original design, construction, workmanship and materials and is recommended for National Register eligibility.

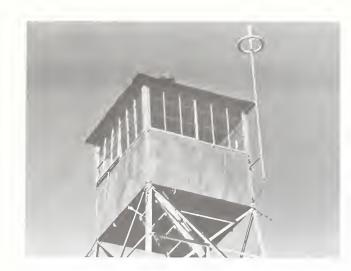
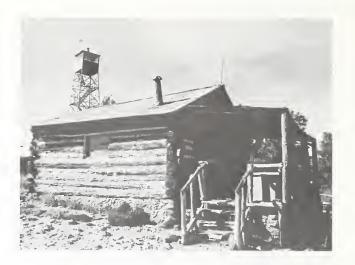
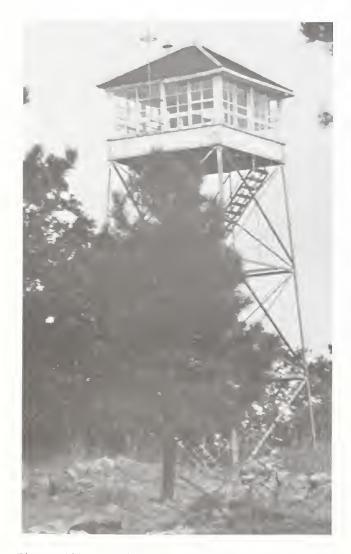
Located on the Black Range Ranger District, this 45 feet high Aermotor MC-40 steel tower has a 7 feet square steel cab and was erected in 1933 (Figures 178 and 179). This lookout replaced a wooden tower built in the early 1920s. The log cabin associated with this lookout (Figure 180) was built in 1925. The modern metal building was built in 1965. Because the lookout tower and cabin have both retained their integrity of original design, construction, workmanship, materials, location, setting and association and are over 50 years of age, they are both recommended for National Register eligibility.

Figure 178. Hillsboro Peak lookout, an Aermotor MC-40, and cabins on the Gila National Forest.

Figure 179. An unusual antenna tops this MC-40 at Hillsboro Peak lookout.

Figure 180. The Hillsboro lookout cabin, Gila National Forest.

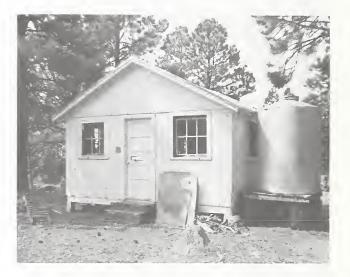
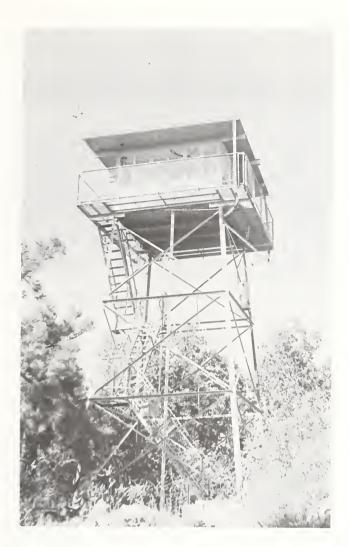
Figure 181. El Caso lookout, an Aermotor MC-24 on Quemado Ranger District.

Figure 182. El Caso lookout's cabin, built in 1934 on the Gila National Forest.

This Aermotor MC-24 lookout tower site (Figures 181 and 182) is located on the Quemado Ranger District. The tower is 30 feet high and has a wooden cab 12 feet square. The tower and associated cabin were both built in 1934. This lookout tower is unchanged from its initial construction. It represents one of the best examples of an Aermotor MC-24 tower and cab in the Southwestern Region. Because both the lookout tower and cabin retain excellent integrity of original design, construction, workmanship, materials, location, setting and association and are over 50 years of age, both of them are recommended for eligibility.

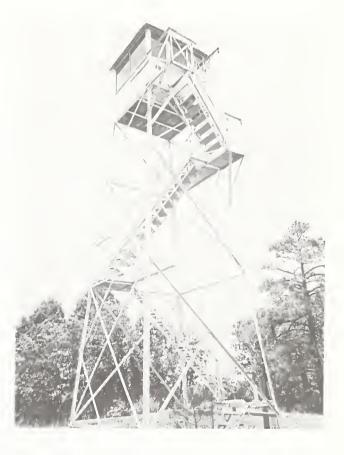
Figure 183. Signal Peak lookout, Gila National Forest (Aermotor MC-40)

Located on the Silver City Ranger District, this 30 feet high Aermotor MC-24 steel tower (Figure 183) was erected in 1932. The original 12 feet square steel cab was replaced in 1966 by a steel cab 14 feet square of the USDA Forest Service Standard Plan CL-100 to CL-106 series type. All of the support buildings were erected in the 1960s. This lookout is recent in design and construction and is not recommended for National Register eligibility.

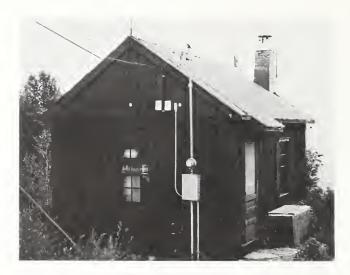
Figure 184. Round Mountain lookout, probably a modified Aermotor MC-39, on the Kaibab.

Located on the Williams Ranger District, this 35 feet high steel tower has a 7 feet square steel cab (Figure 184). It was erected in 1960, after being moved from the Coconino National Forest. The lookout tower appears to be an Aermotor MC-39 type and has experienced some structural changes with new windows and siding. Since this lookout was moved from another location and has been in place less than 50 years, it is not recommended for National Register eligibility.

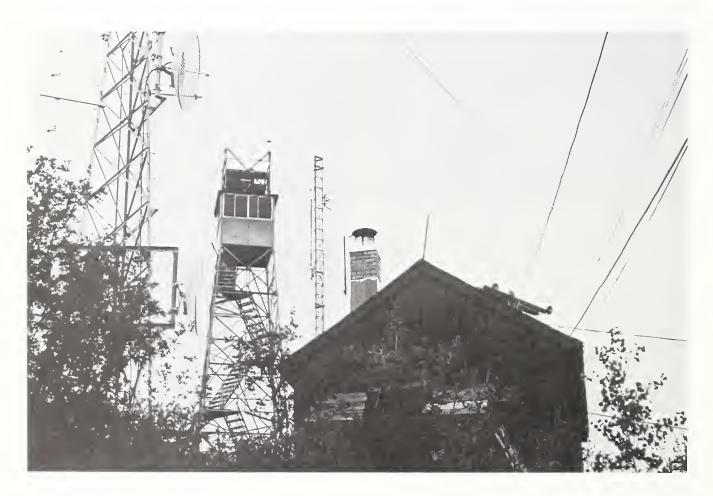
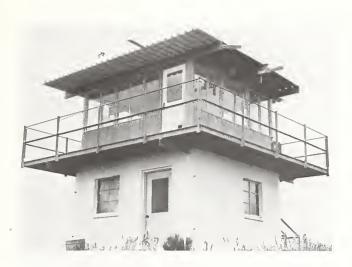
The associated wood frame cabin, built in 1938, measures 18 feet by 8 feet (Figure 185). It also was extensively remodeled in 1968, when a metal roof was installed along with new redwood siding. A shed-roofed addition was built in the last ten years.

Figure 185. Bill Williams lookout cabin was built in 1938 on the Williams Ranger District.

There have been many intrusions at this lookout site including nine buildings and microwave towers associated with private industry (Figure 186). This lookout tower and cabin have lost

Figure 186. Bill Williams lookout (an Aermotor MC-39) and cabin on the Kaibab National Forest.

their integrity of original design, construction, workmanship, materials, location and setting and are not recommended for National Register eligibility.

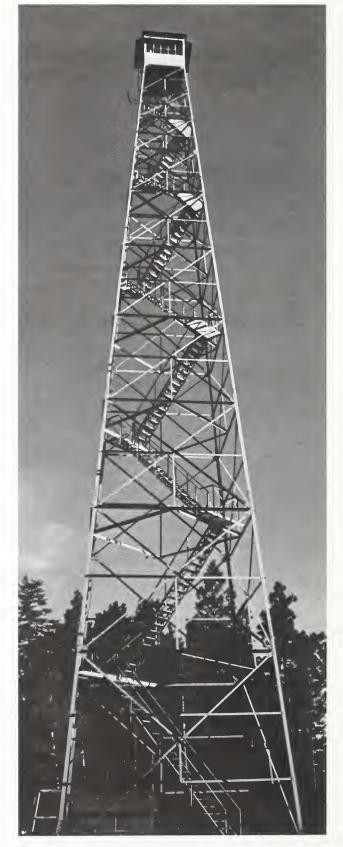
Figure 189. Big Springs lookout, another Aermotor MC-39, on the Kaibab National Forest.

Big Springs Lookout (Figure 189) was erected for the USFS in 1934 by contractors from Kanab, Utah. The 100 feet high steel tower has a steel cab 7 feet square and is located on the North Kaibab Ranger District. This lookout is an Aermotor MC-39 type. The associated 18 feet by 24 feet wooden frame cabin was built in 1959 to replace an earlier log cabin. Study of historic photographs indicates few structural changes have occurred since the lookout was built. Because the lookout tower is over 50 years of age and has retained its integrity of original design, construction, workmanship, materials, setting, location and association, it is recommended for National Register eligibility.

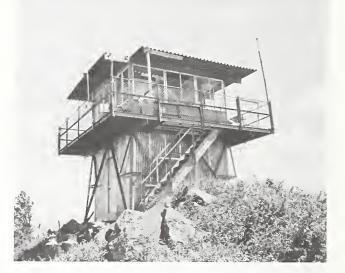
Located on the Tusayan Ranger District, the Red Butte Lookout (Figure 194), erected in 1980, is the most recent lookout built in the Southwestern Region. The plan was created specifically by the

Figure 194. Red Butte lookout, a CL-100 series, Kaibab National Forest.

Engineering Department of the Kaibab National Forest. It is based on the USDA Forest Service Standard Plan CL-100 to CL-106 series type. The two-story cab is constructed of reverse board and batten stained wood. It has aluminum frame fixed and sliding windows. The wood frame storage shed is the same age. This lookout replaced an earlier Aermotor tower built in the 1930s. The lookout and associated storage shed are less than 50 years old, do not represent an exceptional type and are not recommended for National Register eligibility.

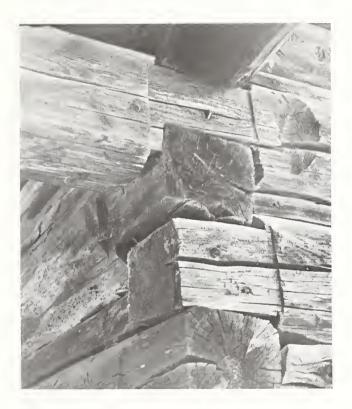
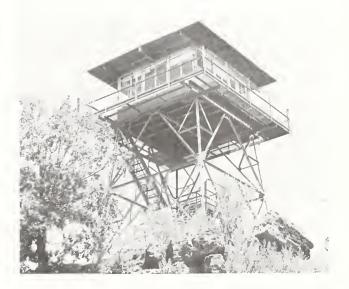
The cabin (Figure 196), located approximately 1500 feet from the lookout, was built in 1911 by fire lookout guard, Bill Williams. He lived in there and hiked up to the top of the mountain during the day to watch for smoke. The cabin was used until the early 1930s. It is still standing and is in excellent condition. It is used today as a hiker's shelter.

The cabin measures 9 feet by 12 feet, has a simple, corrugated tin gable roof with deeply overhanging eaves, a round debarked ridge pole and purlins. The logs in the walls are joined with square notches at the corners (Figure 197). The mortar between the joints is concrete. The foundation consists of basalt blocks with concrete mortar. The cabin has a wood plank floor, one wood plank door on the south end and windows on the east and west sides. This cabin is the second oldest example of a fire detection

Figure 196. Kendrick lookout's cabin was built by Bill Williams in 1911.

Figure 197. This corner view shows the quality of Williams' square notching work.

Because the cabin is over 50 years of age and retains its integrity of original design, construction, workmanship, materials, location and setting, it is recommended for National Register eligibility. The lookout tower is not recommended for National Register eligibility as it is less than 50 years old and does not represent an exceptional type.

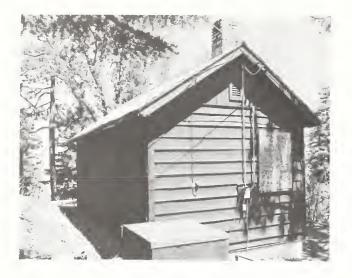
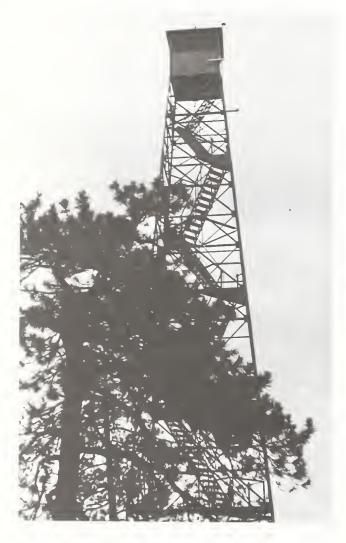
This lookout (Figure 198) is also located on the Chalender Ranger District and was erected in 1963. The steel lookout tower is 30 feet high and has a steel cab 14 feet square. It is a USDA Forest Service Standard Plan CL-100 to CL-106 series type. It was built by the USFS and the Navajo Army Depot and is still jointly operated. It replaced an earlier 16 feet high wood tower with a 7 feet square cab built in 1932.

The associated wooden frame cabin (Figure 199) was built in 1939 to USFS Plan B-16. It has a gable roof and is constructed on the same plan as the Grandview Lookout cabin with some differences in detailing such as wider weather board siding. The cabin has a simple gable roof with asphalt shingles, exposed rafters and brown-painted wooden siding. It has wood sash windows. The cabin sits on a poured concrete foundation. The interior has two rooms, a kitchen and a bedroom.

Figure 198. Volunteer lookout, a CL-100 series, was built in 1963 on the Kaibab National Forest.

Figure 199. Volunteer lookout's cabin was built in 1939, on the Kaibab National Forest.

Because the cabin at this site meets the age requirements and has retained its integrity of original design, construction, materials, workmanship, setting and location, it is recommended for National Register eligibility. The lookout tower is less than 50 years old, does not represent an exceptional type or style and is not recommended.

Figure 200. Grandview lookout, an Aermotor MC-39, is 80 feet tall and was built in 1936.

This lookout (Figures 200 and 201) is located on the Tusayan Ranger District and was built in 1936. The steel lookout tower is 80 feet tall and has a steel cab 7 feet square. It is an Aermotor MC-39. This tower replaced an earlier log tower and platform built in the 1920s.

The wooden frame cabin was also built in 1936 and is from Forest Service Plan B-16. The cabin measures 12 feet by 22 feet and has two rooms. It has a shingled gable roof with overhanging eaves and exposed rafters. The eave above the front door is extended and supported by knee brackets with diamond cut purlins. The cabin has weather-board siding and a poured concrete foundation.

Because the lookout tower and cabin are both over 50 years old and have retained their integrity of original design, construction, workmanship, materials, setting, location and association, both are recommended for National Register eligibility.

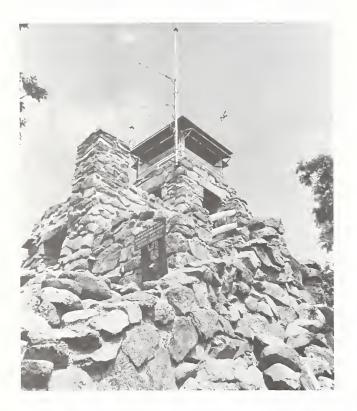
Figure 202. Monjeau lookout, a 7 feet square steel cab on a distinctive native stone tower.

Monjeau, located on the Smokey Bear Ranger District, was built by a CCC crew in 1940. This is one of the most unique lookouts in the Southwestern Region (Figures 202 and 203) [Also, see Figure 50 for an earlier view]. It is illustrated in the USFS Standard Lookout Planbook originally published in 1938.

The Monjeau lookout has a metal cab 7 feet square manufactured by International Derrick set on a native stone tower 14 feet square. The cab is for observation only; living quarters are located below in the stone tower. The cab and tower plan (No. B6601) was provided by the International Derrick Company. The Monjeau lookout replaced an earlier D-6 cupola type lookout house built in the early 1930s. The Monjeau lookout is located at an elevation of 9,641 ft and is a popular visiting spot for tourists. This tower represents an excellent example of the "rustic style" construction type utilized by the CCC for the National Park Service and USFS buildings. It is the only example of a lookout in the Southwestern Region that utilized that style.

architectural lookout type in the Southwestern Region and has retained its integrity of original design, construction, setting, location, workmanship and materials, it is recommended for National Register eligibility. Due to other areas of significance, the replacement of windows at the Monjeau lookout is not regarded as disqualifying.

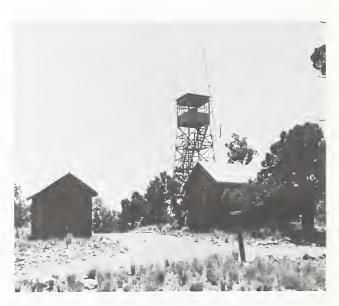
Figure 204. Dark Canyon lookout, an Aermotor MC-99, and cabins on Lincoln National Forest.

Located on the Guadalupe Ranger District, the Dark Canyon lookout (Figure 204), is a 48 feet high steel tower with a steel cab 7 feet square. An Aermotor MC-99 type, it was erected in 1948 or 1949. It is one of only two Aermotor MC-99 types that still stand in the Southwestern Region. The other is located on the Kaibab National Forest [See Figure 190].

The Dark Canyon site has been utilized for fire detection since 1910. Two tall pine trees with ladders and platforms were first utilized for lookouts. A log cabin was built to house the lookout personnel. No remains of any of these structures can be seen today. In the late 1930s, the CCC destroyed the log cabin and built the present cabin and toolshed.

The cabin and tool shed also have been modified. The original shiplap fir roofs were replaced, first by cedar shingles, and then in 1976 by a tin roof. In 1984, both buildings received new aluminum siding. The tower's modifications were primarily confined to the interior. This lookout has been moved, losing its integrity of location and is not recommended for National Register eligibility.
